Investigation of Deterioration of Joints in Concrete Pavements

National Concrete Pavement
Technology Center

Final Report
August 2012

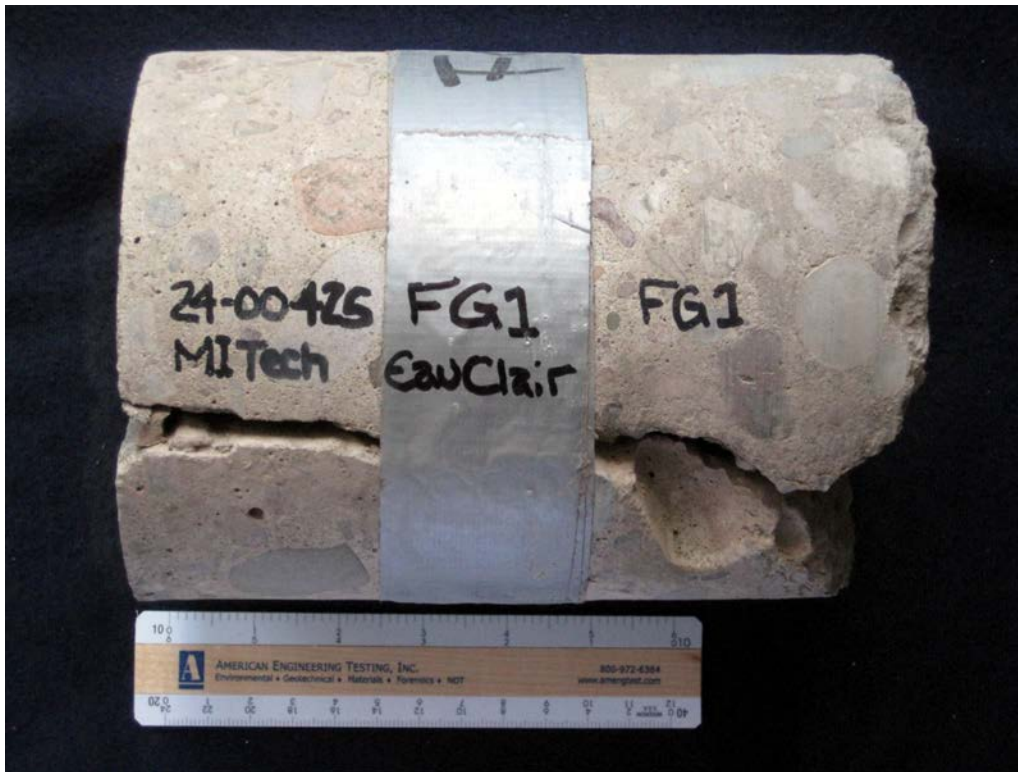
PHOTO: 1

3. Core FG1 was centered and taken directly through a silicone sealed, sawcut control joint. The top surface of the core exhibited minor mortar erosion. The silicone sealant was intermittently de-bonded on both side of the joint and the sawcuts were in relatively pristine condition; apart from "rounding" and wear of the top surface edges. The distress in core FG1 is confined to mass lost, incipient vertical spalling, and altered paste generally below the depth of the greatest extent of the pilot sawcut of the jointing (53mm). The greatest mass loss of approximately 15mm of concrete occurs between approx. 105mm and 135mm depth in the core. The greatest extent of incipient distress (vertical spalling) occurs generally below 142mm depth in the joint and becomes more horizontal in orientation within 30mm of the bottom surface of the core.

SAMPLE ID: FG1 **DESCRIPTION:** Core sample taken directly through a joint as received. Top surface is left.

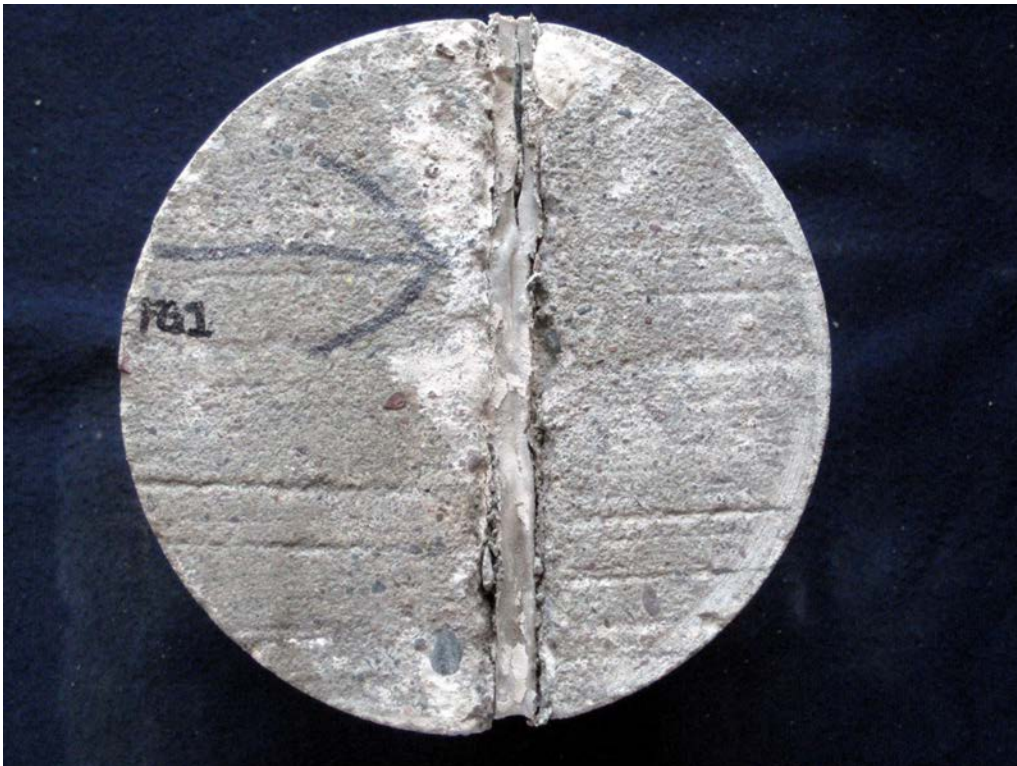
PHOTO: 2

SAMPLE ID: FG1 **DESCRIPTION:** Top surface of the core as received. Note core was taken through a sawcut and silicone sealed control joint.

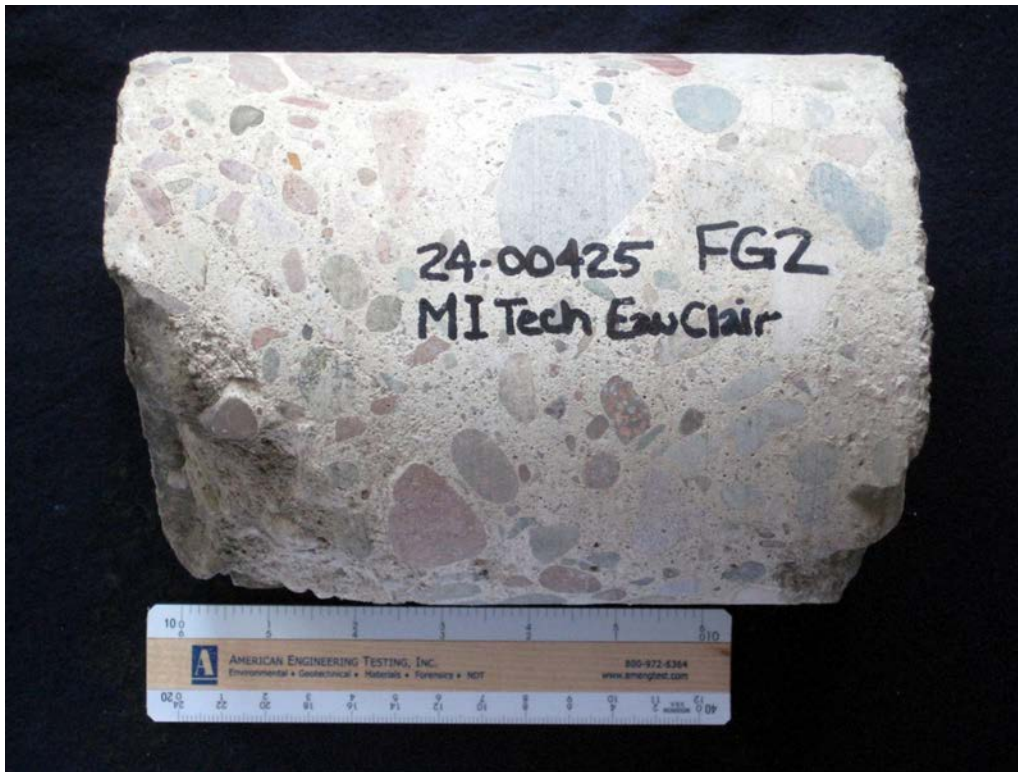
PHOTO: 3

4. Core FG2 was taken offset from the joint and no evidence of the resulting joint crack was intersected. The distress in the core was characterized by a loss of the top surface of the concrete at an approx. 45° to 50mm depth into the joint. Incipient damage, in a similar orientation, extends to 106mm depth into the core. No evidence of sawcutting or joint sealant remains with the sample.

SAMPLE ID: FG2 **DESCRIPTION:** Core sample taken directly through a joint as received. Top surface is left.

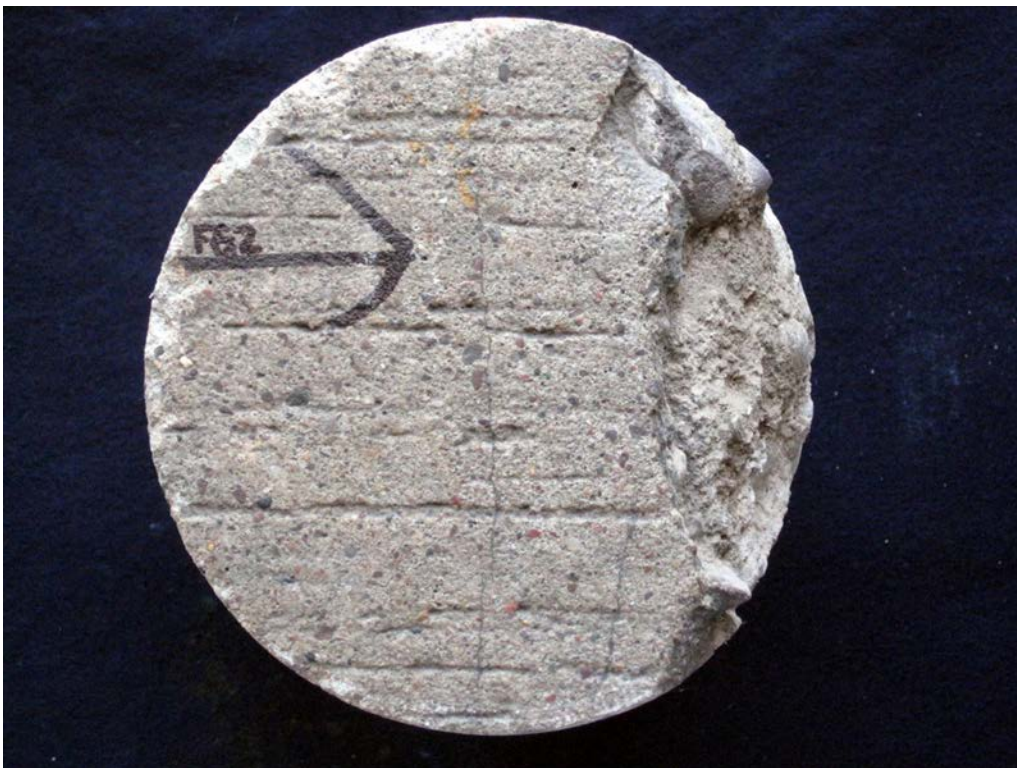
PHOTO: 4

SAMPLE ID: FG2 **DESCRIPTION:** Top surface of the core as received. Note core was taken in distress apparently directly adjacent to a control joint..

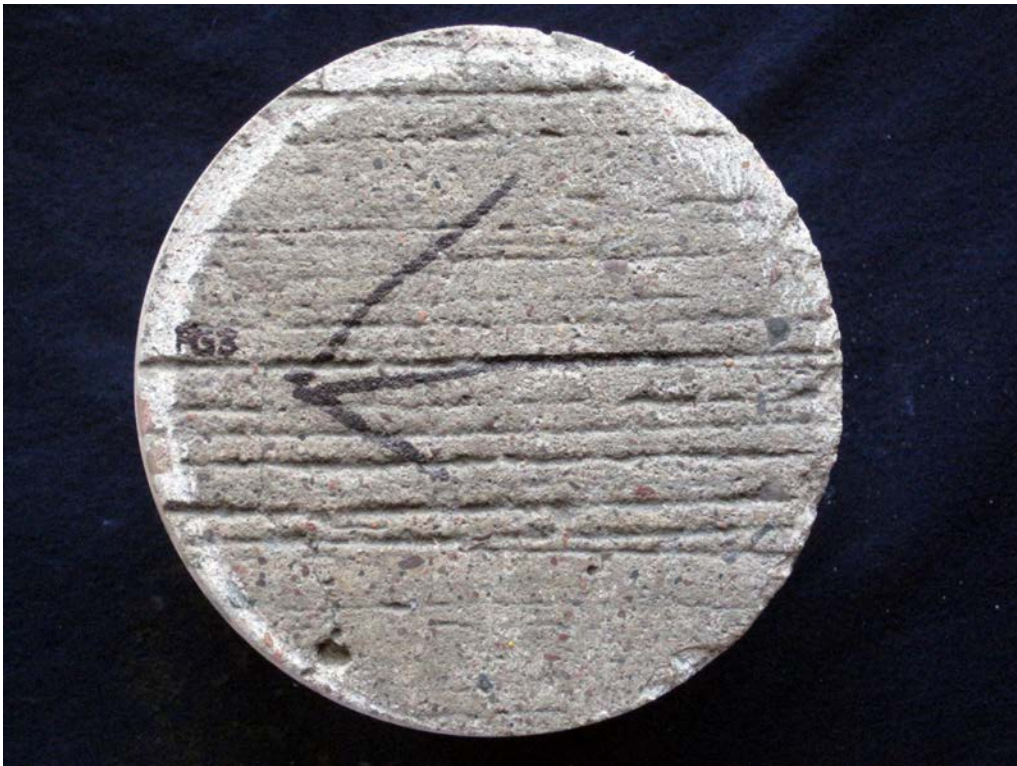
PHOTO: 6

SAMPLE ID: FG3 **DESCRIPTION:** Screeded, tined and traffic worn top surface of the core as received.

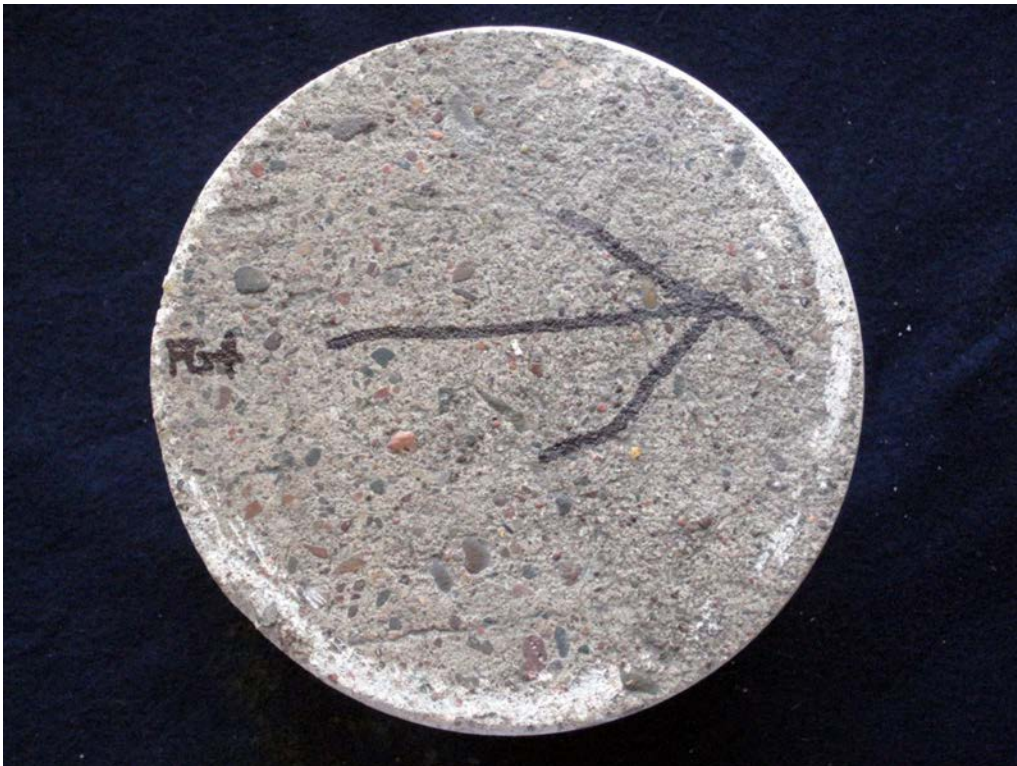
PHOTO: 8

SAMPLE ID: FG4 **DESCRIPTION:** Mortar eroded top surface of the core as received.

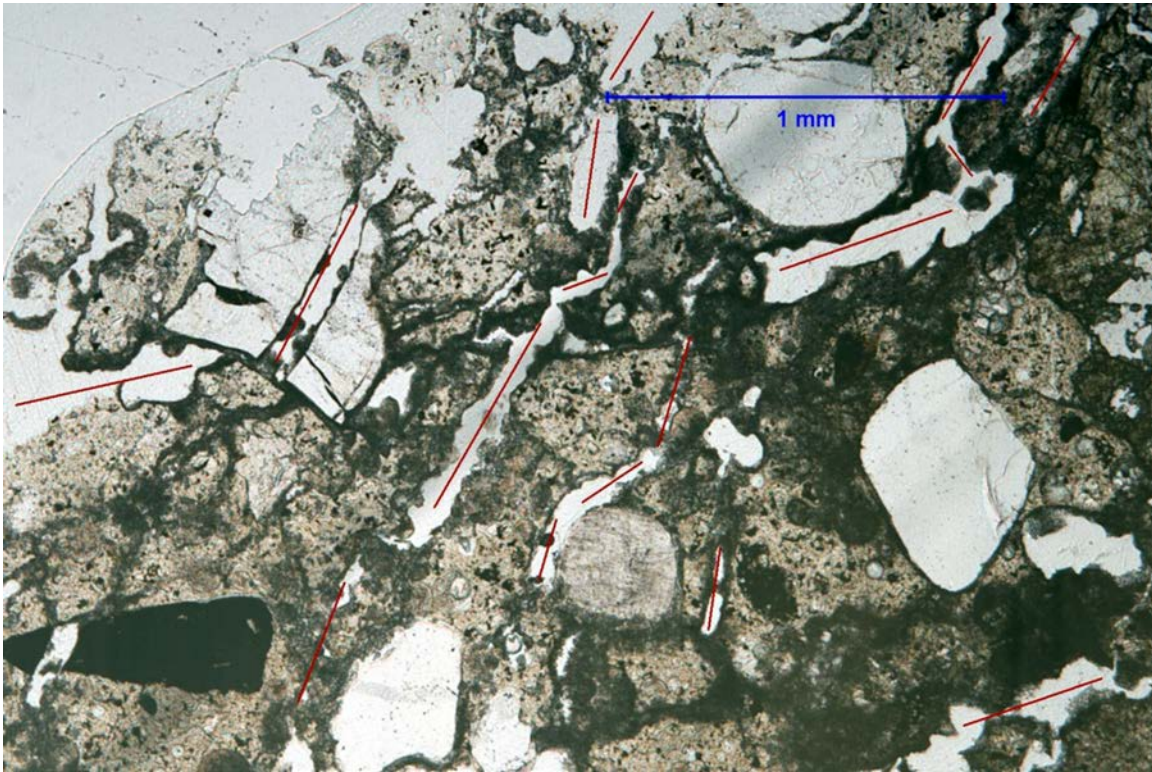
PHOTO: 15

SAMPLE ID: FG1 DESCRIPTION: Highly concentrated anastomosing microcracking (mapped in red dashed line) in carbonated paste directly adjacent to the distressed joint plane (top of image); in thin section concrete under plane polarized light.
MAG: 40x

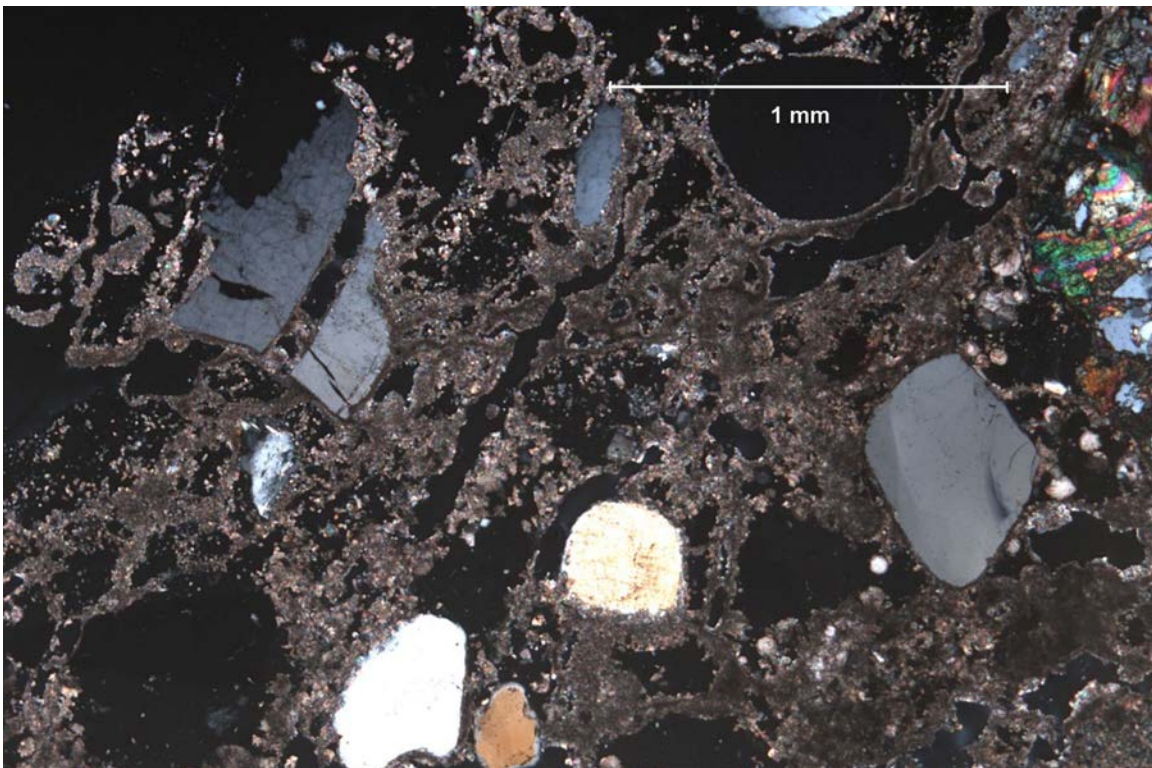
PHOTO: 16

SAMPLE ID: FG1 DESCRIPTION: Previous view of the concrete thin section under cross polarized light. Note brightly colored, carbonated to "bi-carbonated" paste.
MAG: 40x

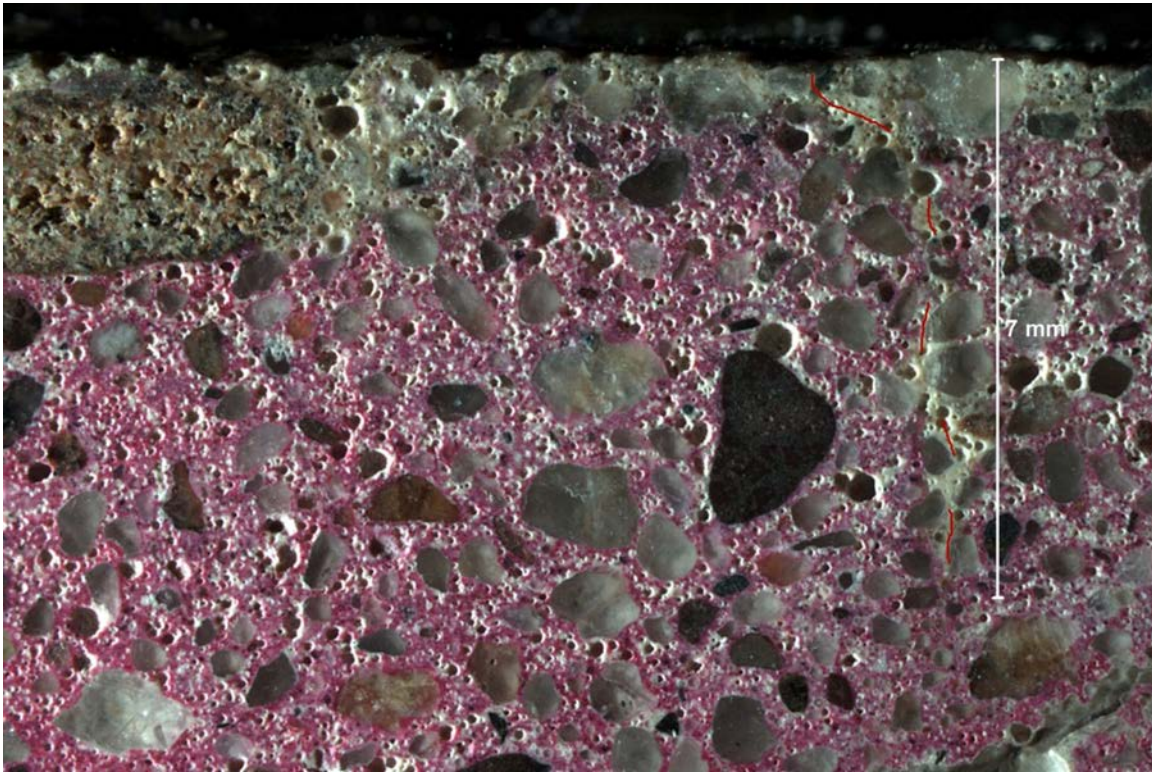
PHOTO: 19

SAMPLE ID: FG2 **DESCRIPTION:** Carbonation (unstained paste) ranges from <1mm to 7mm depth (in this view) along fine drying shrinkage microcracking mapped in red dashed line.
MAG: 10x

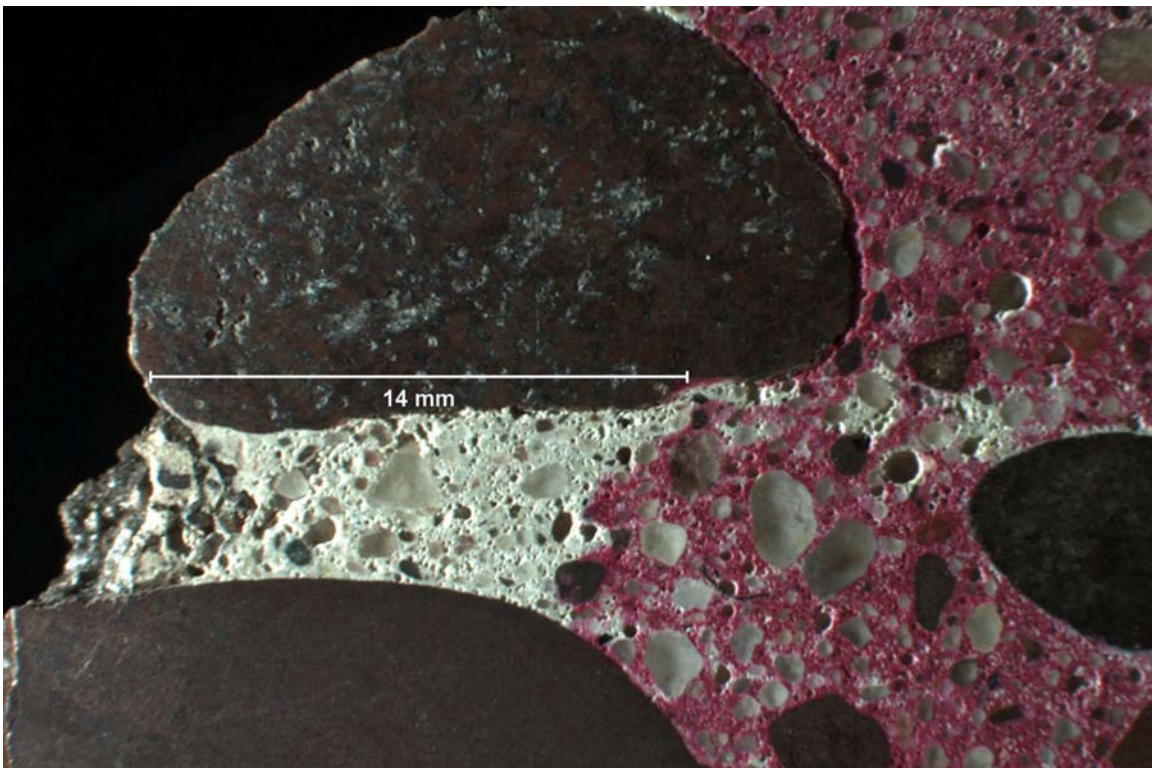
PHOTO: 20

SAMPLE ID: FG2 **DESCRIPTION:** Carbonation (unstained paste) proceeds continuously to 14mm from the distressed joint plane at approx. 16mm depth in the core.
MAG: 5x

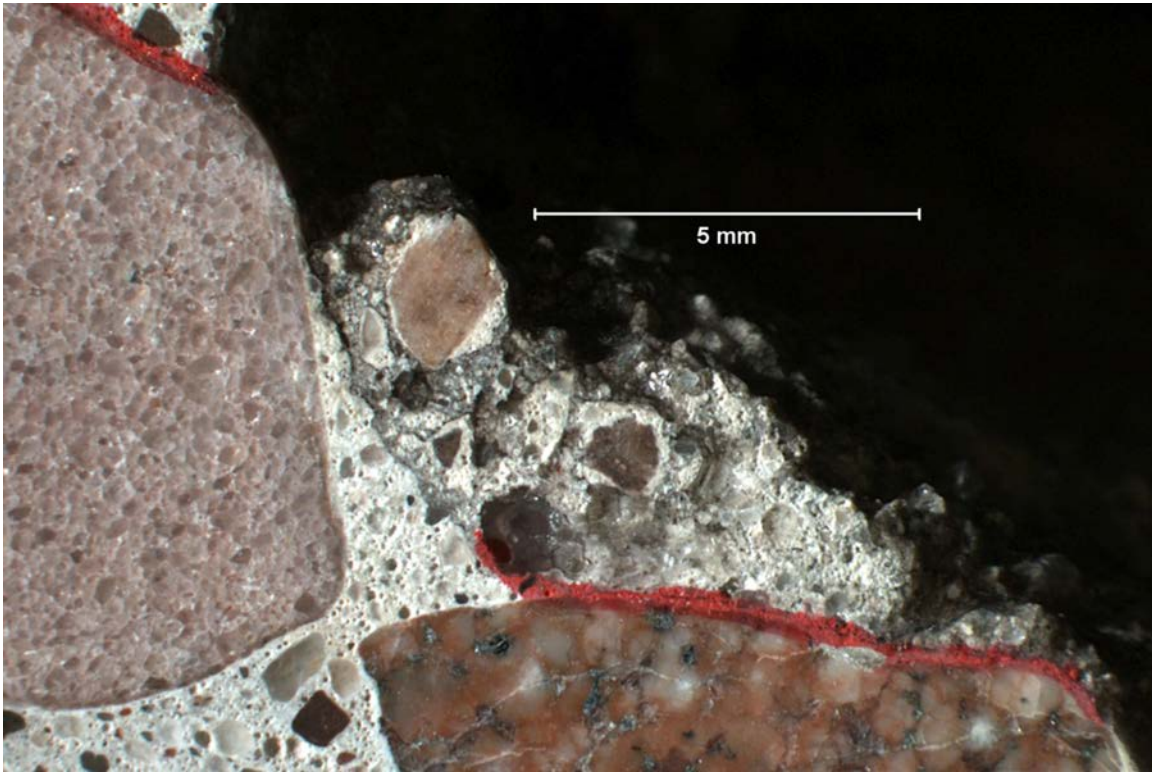
PHOTO: 21

SAMPLE ID: FG2 **DESCRIPTION:** Concrete fragments along the distressed edge of the core; apparently lightly cemented with calcite and stabilized with epoxy for preparation.
MAG: 10x

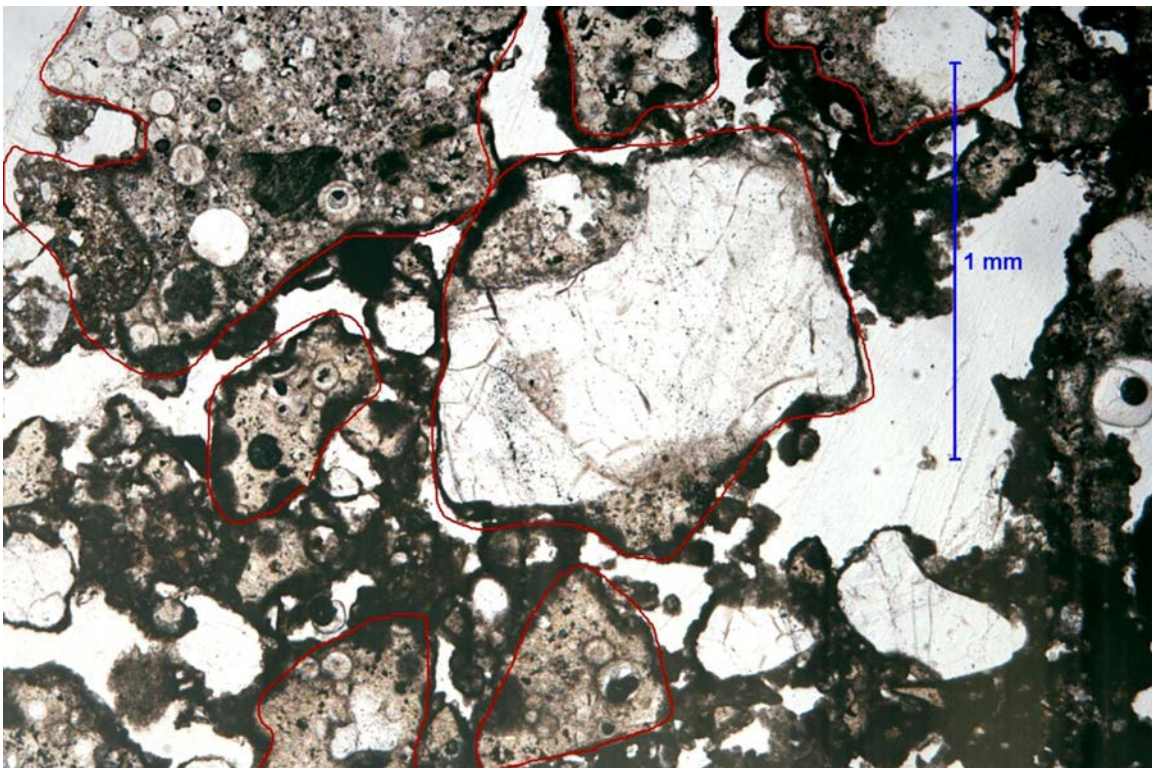
PHOTO: 22

SAMPLE ID: FG2 **DESCRIPTION:** Concrete fragments in thin section (outlined in red) along the distressed edge of the core; apparently lightly cemented with calcite and stabilized with epoxy for preparation
MAG: 40x

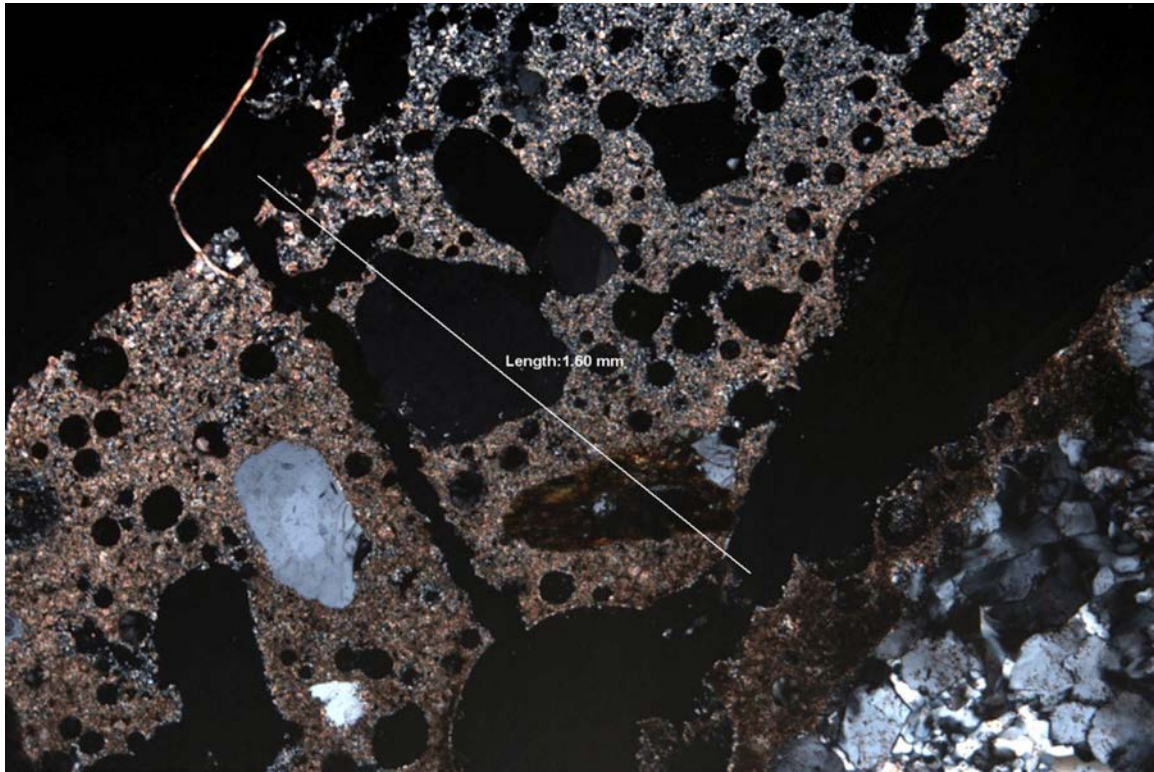
PHOTO: 23

SAMPLE ID: FG2 **DESCRIPTION:** Brightly colored, carbonated paste directly adjacent to the distressed joint plane (upper left); in thin section under cross polarized light.
MAG: 40x

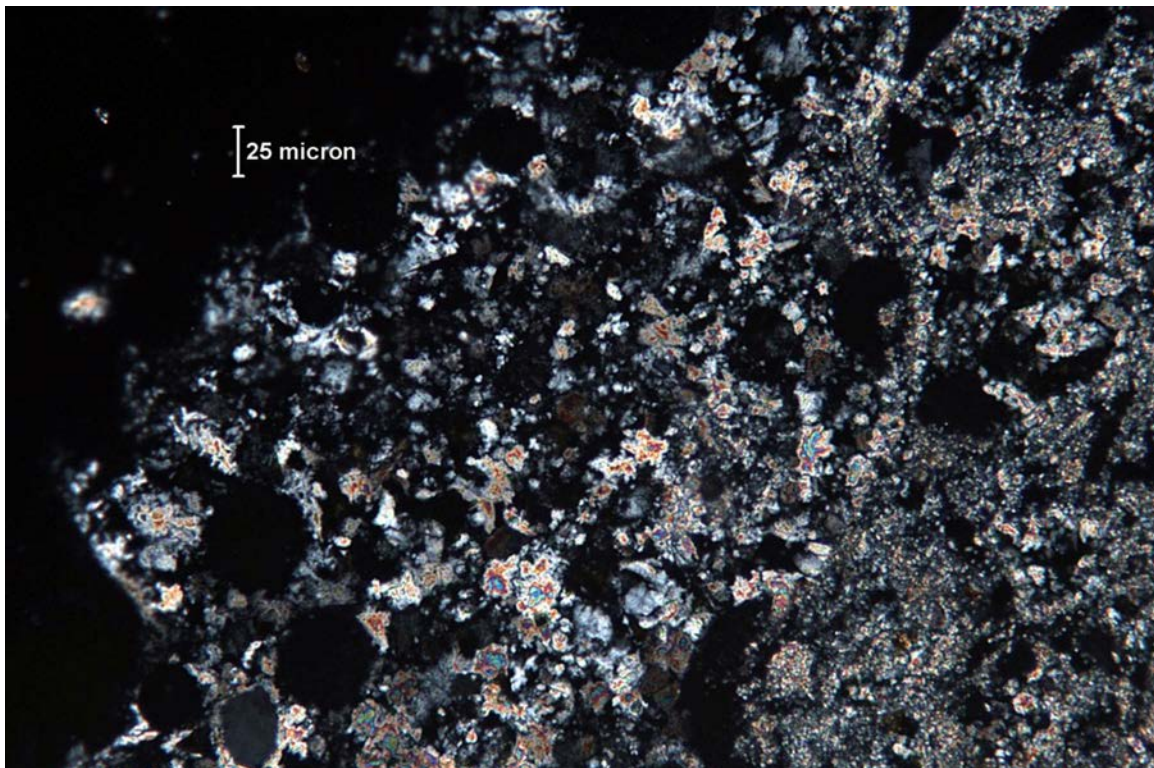
PHOTO: 24

SAMPLE ID: FG2 **DESCRIPTION:** The paste directly adjacent to the distressed surface appears "bi-carbonated" and exhibits a relatively coarse crystalline appearance under cross polarized light.
MAG: 200x

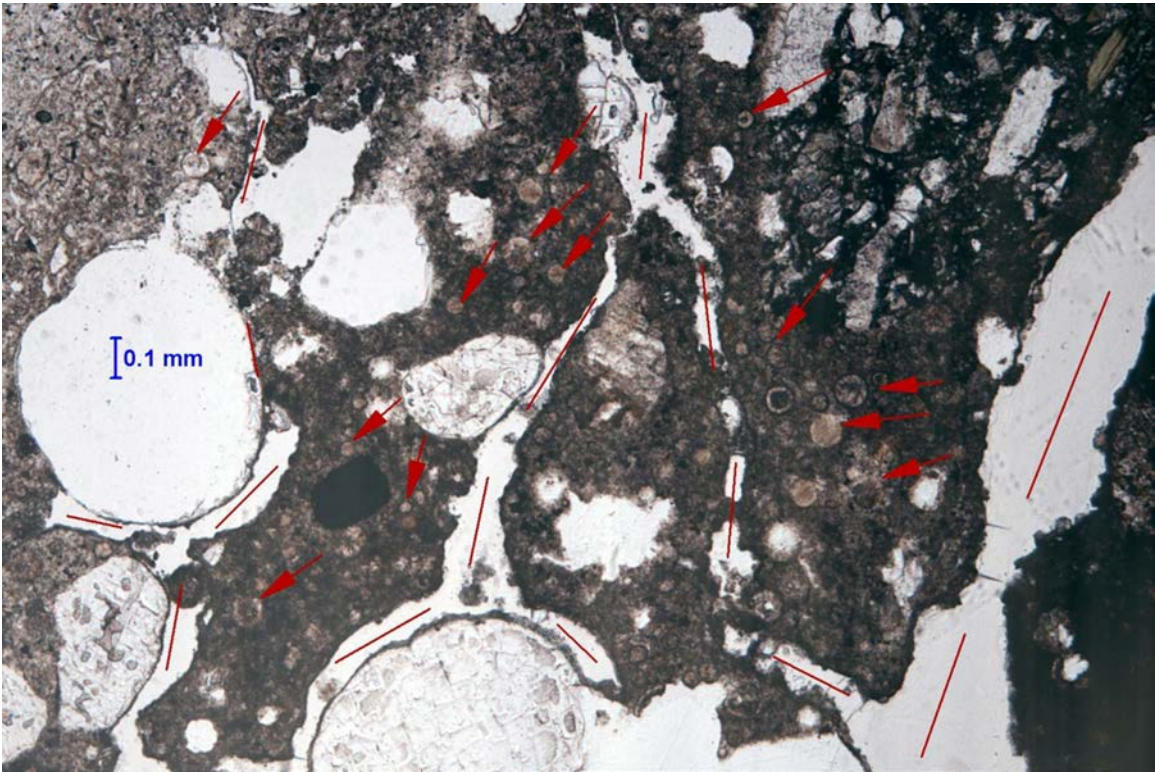
PHOTO: 25

The paste within a few millimeters of the distressed surface exhibits significant secondary ettringite air void fillings (outlined in red); in thin section of heavily microcracked paste (red dashed lines) under plane polarized light.

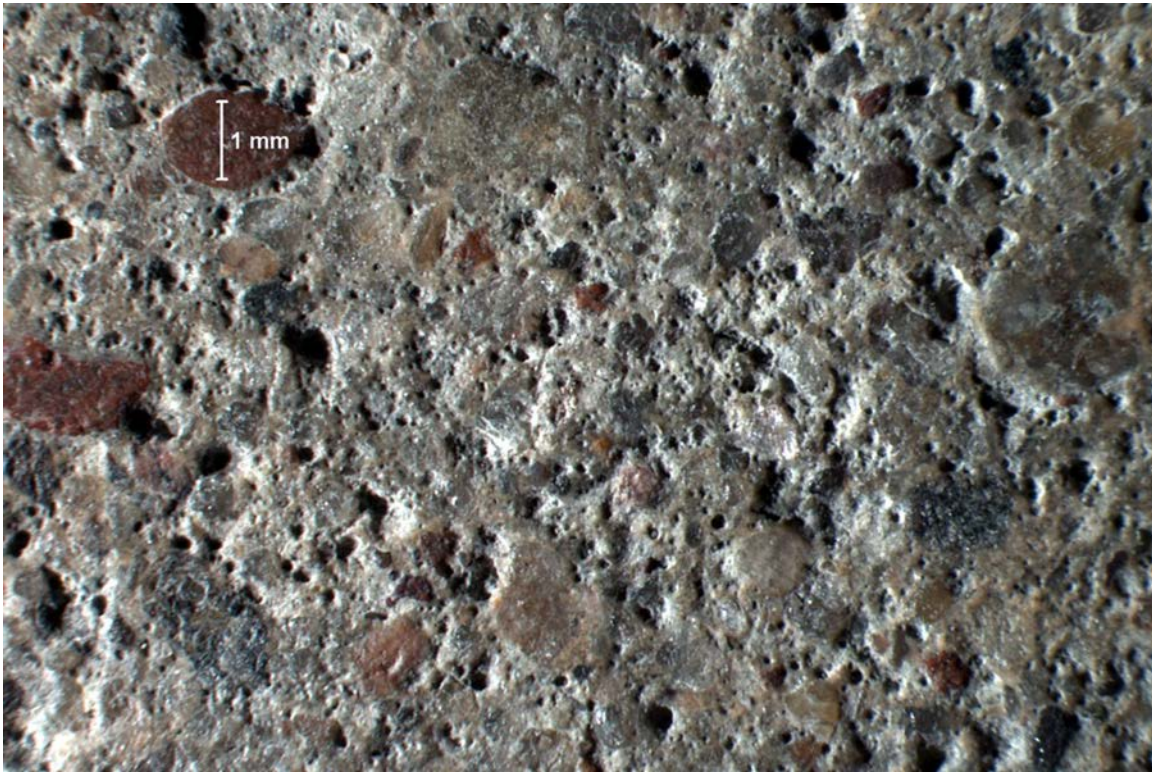
PHOTO: 27

SAMPLE ID: FG3 **DESCRIPTION:** Traffic-worn top surface of the concrete under magnification

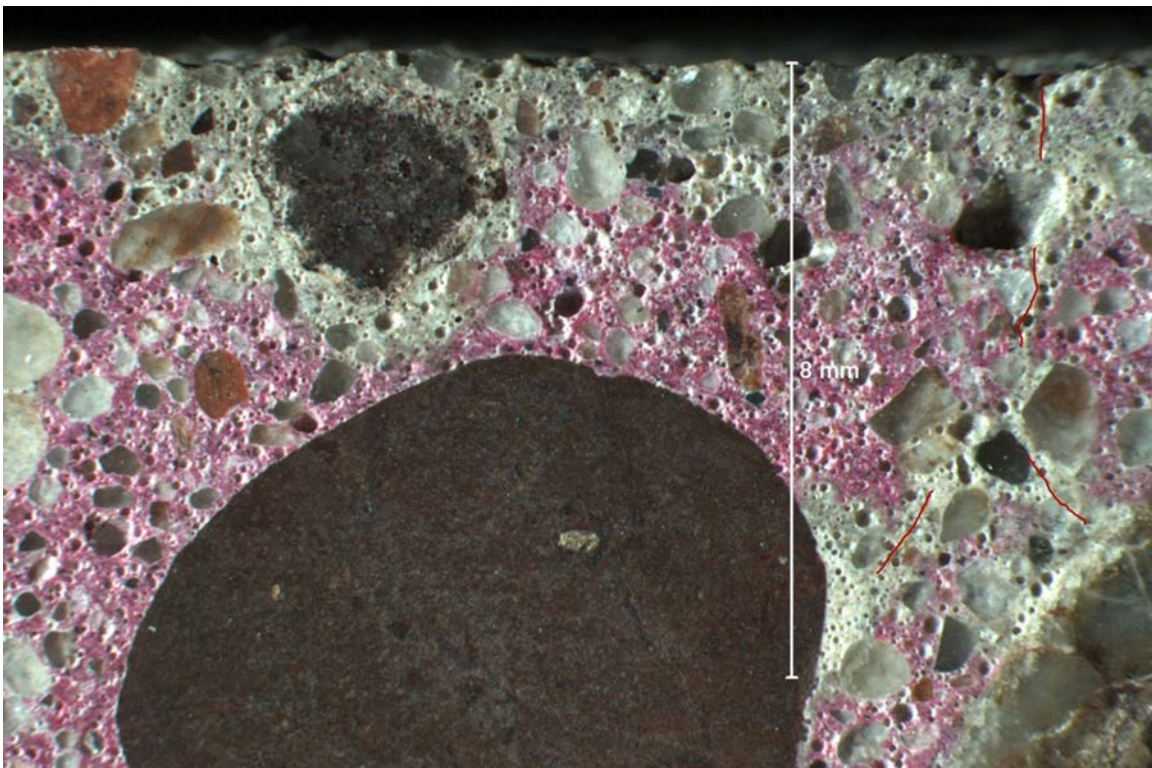
PHOTO: 28

SAMPLE ID: FG3 **DESCRIPTION:** Carbonation (unstained paste) proceeds up to 8mm depth from the top surface, "spiking" along sub-vertical drying shrinkage microcracking mapped in red dashed line.

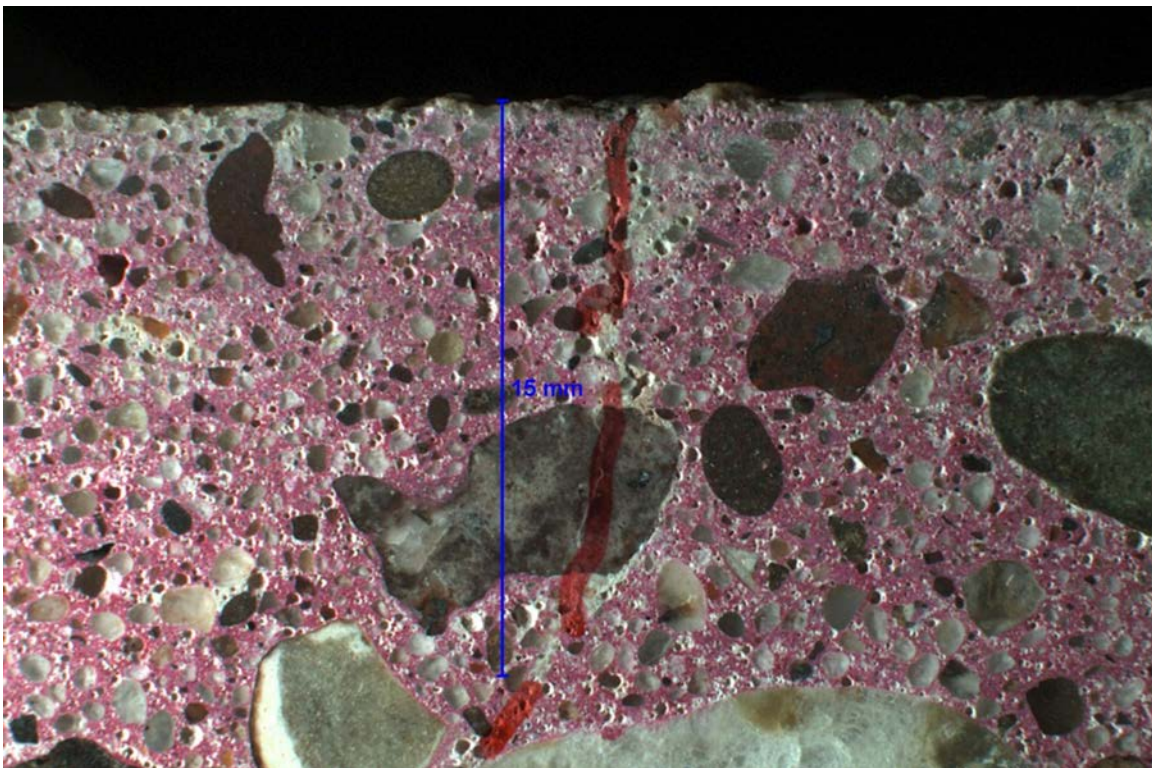
PHOTO: 32

SAMPLE ID: FG4 **DESCRIPTION:** Carbonation (unstained paste) ranges from negligible up to 15mm depth, intermittently, from the top surface of the core, along sub-vertical drying shrinkage microcracking; mapped in red ink.

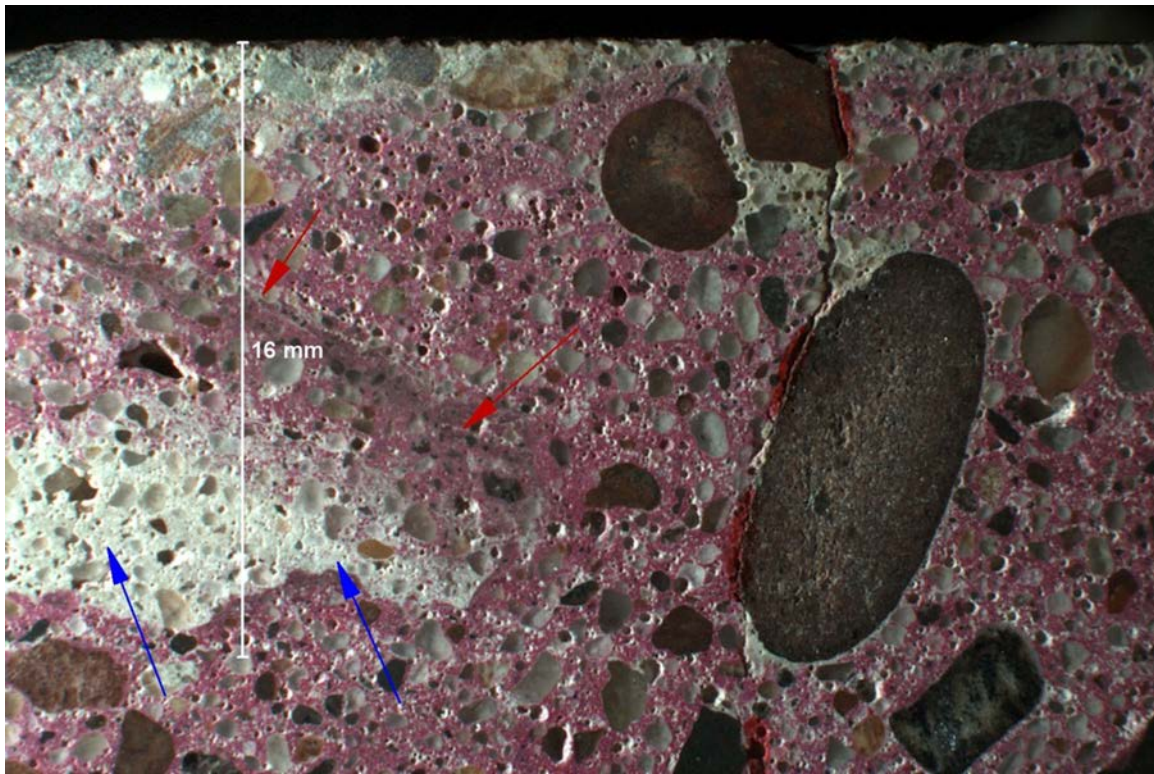
PHOTO: 33

FG4 **DESCRIPTION:** Mixing anomaly within 16mm of the top surface of the core. Note darker, denser layer of concrete (red arrows) and layer of carbonated (unstained paste) excessive w/cm paste (blue arrows).

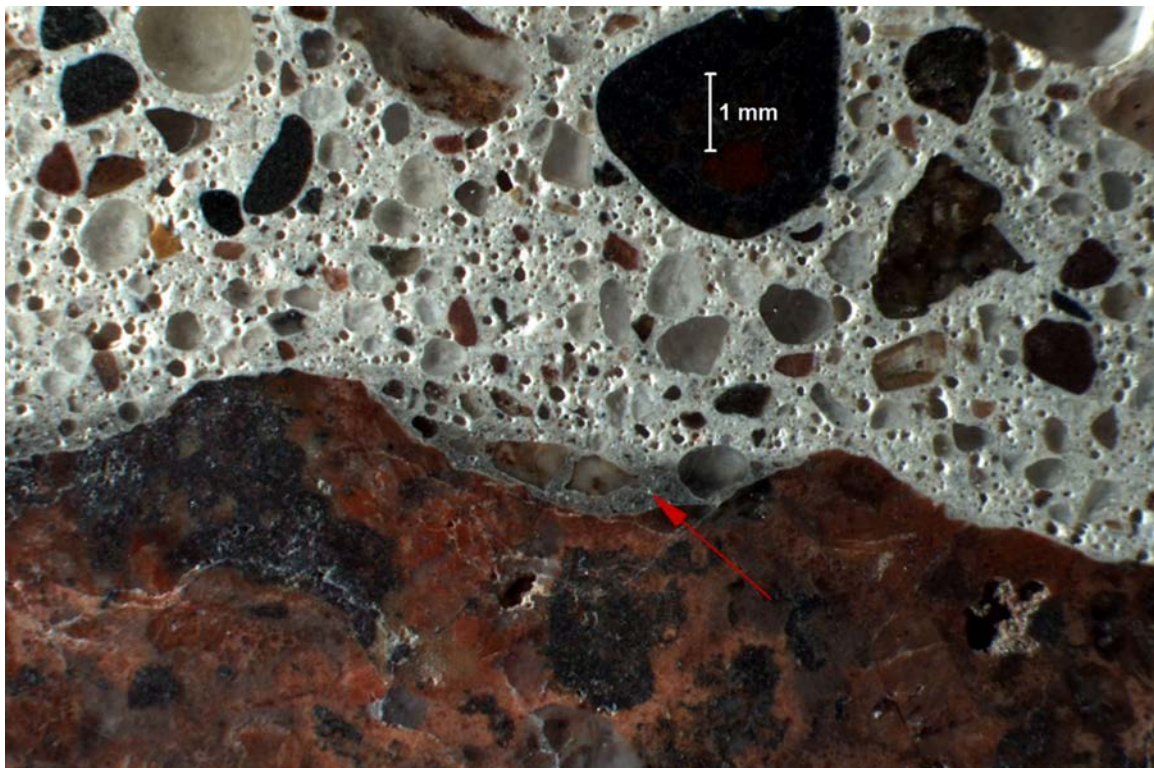
PHOTO: 34

FG4 **DESCRIPTION:** Darker colored, denser paste in concave coarse aggregate notch suggest multiple additions of water to the concrete.

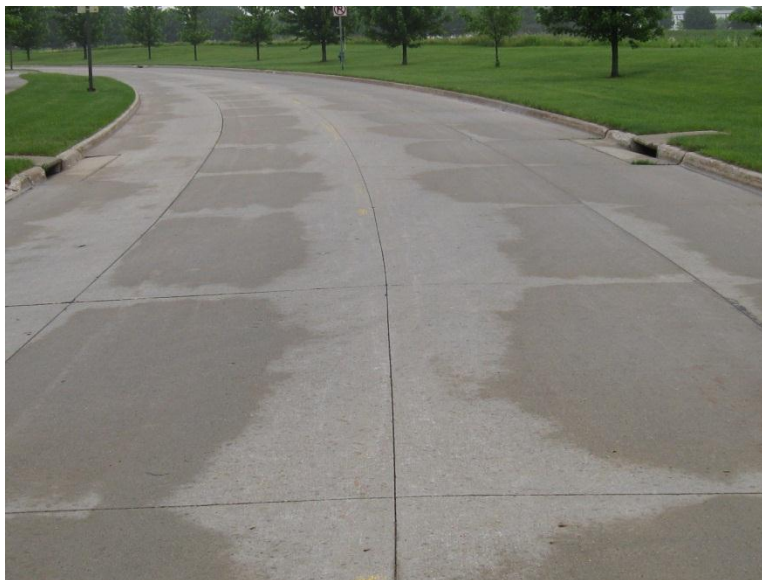
Figure 1. Evidence of joints that are draining well

This drainable base is evidenced by the dry joints and wet surface observed after a rainstorm in the summer of 2011 (Figure 1). At the time, it was noted that the drains were running with water.

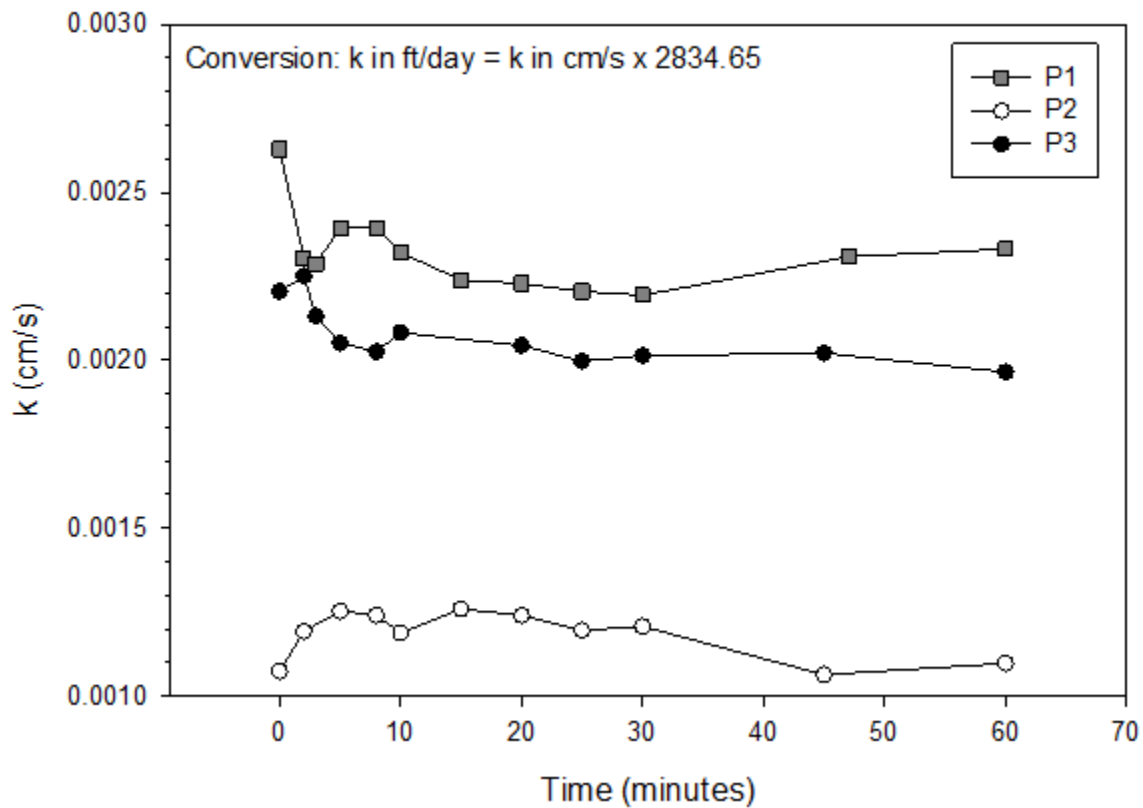
Figure 8. Permeability results

The lowest permeability was observed under the center-line joint. There is little difference between the area with or without distress. There is no trend associated with the sealed and unsealed areas.

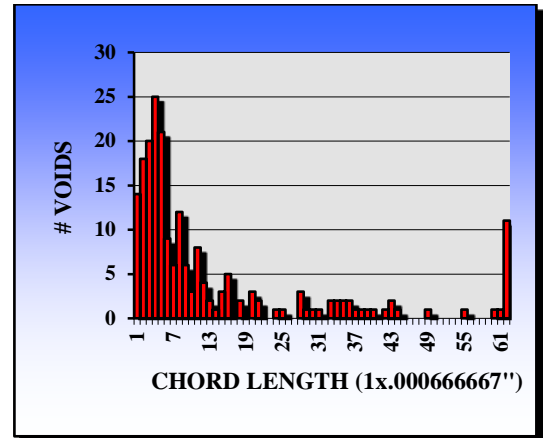
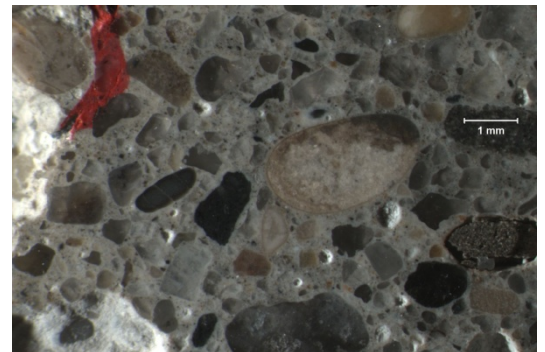
Air Void Content %	4.5
Entrained, % < 0.040"(1mm)	2.9
Entrapped, % > 0.040"(1mm)	1.6
Air Voids/inch	4.2
Specific Surface, in ² /in ³	380
Spacing Factor, inches	0.013
Paste Content, % estimated	26
Magnification	75x
Traverse Length, inches	48
Test Date	4/19/12

Description: Air void system- 145mm depth in core at the joint.

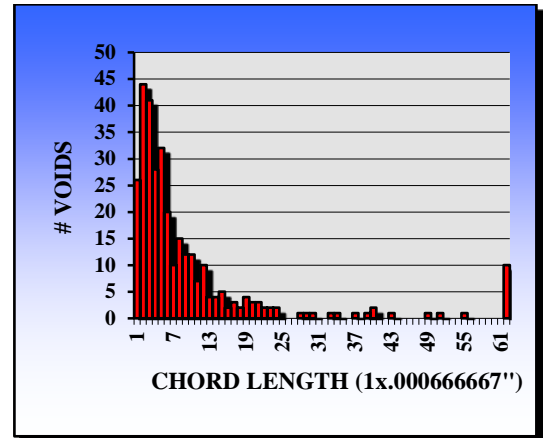
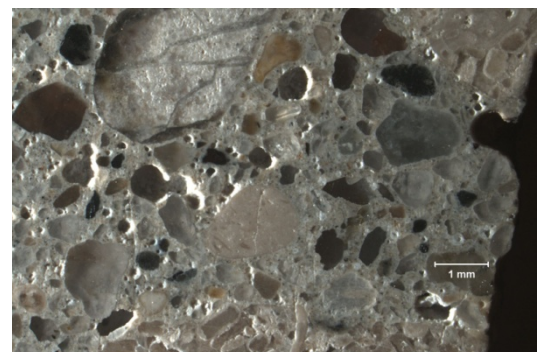
Air Void Content %	5.3
Entrained, % < 0.040"(1mm)	3.5
Entrapped, % > 0.040"(1mm)	1.8
Air Voids/inch	7.0
Specific Surface, in ² /in ³	520
Spacing Factor, inches	0.009
Paste Content, % estimated	26
Magnification	75x
Traverse Length, inches	45
Test Date	4/22/12

Description: Air void system- 60mm depth in core @ joint.

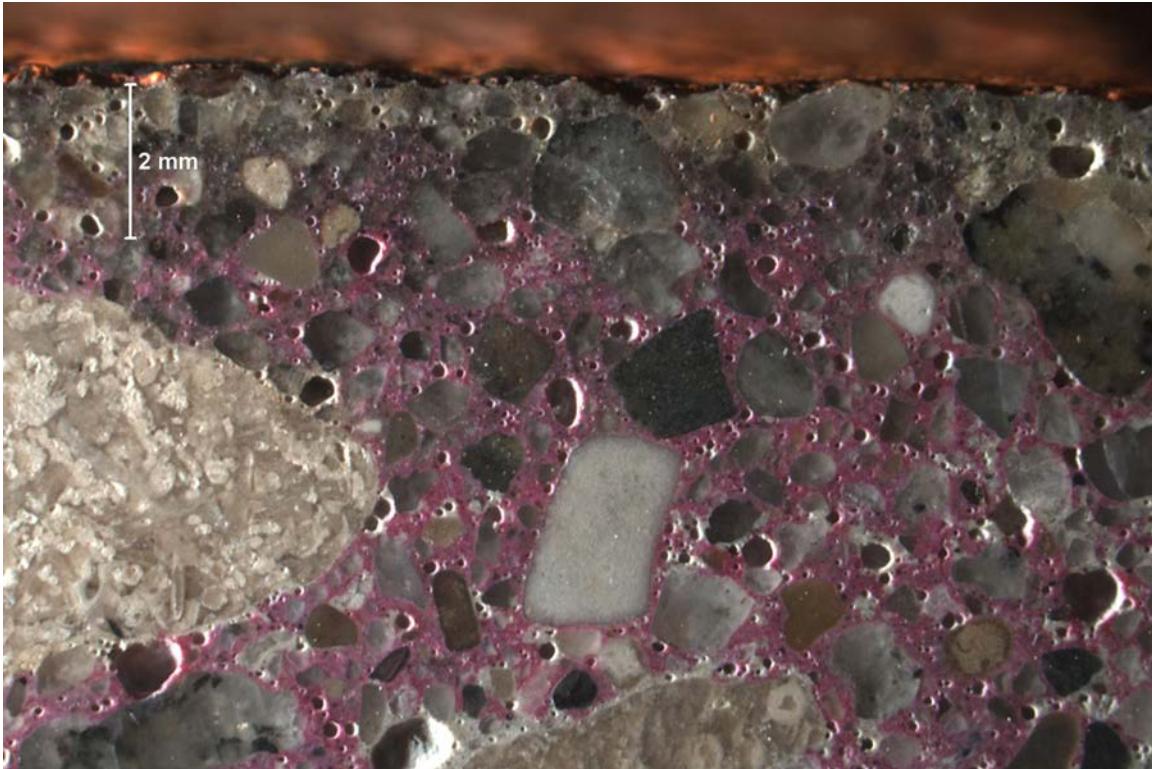
PHOTO: 13

SAMPLE ID: D **DESCRIPTION:** Carbonation (unstained paste) to 2mm depth from the top surface, in this view.

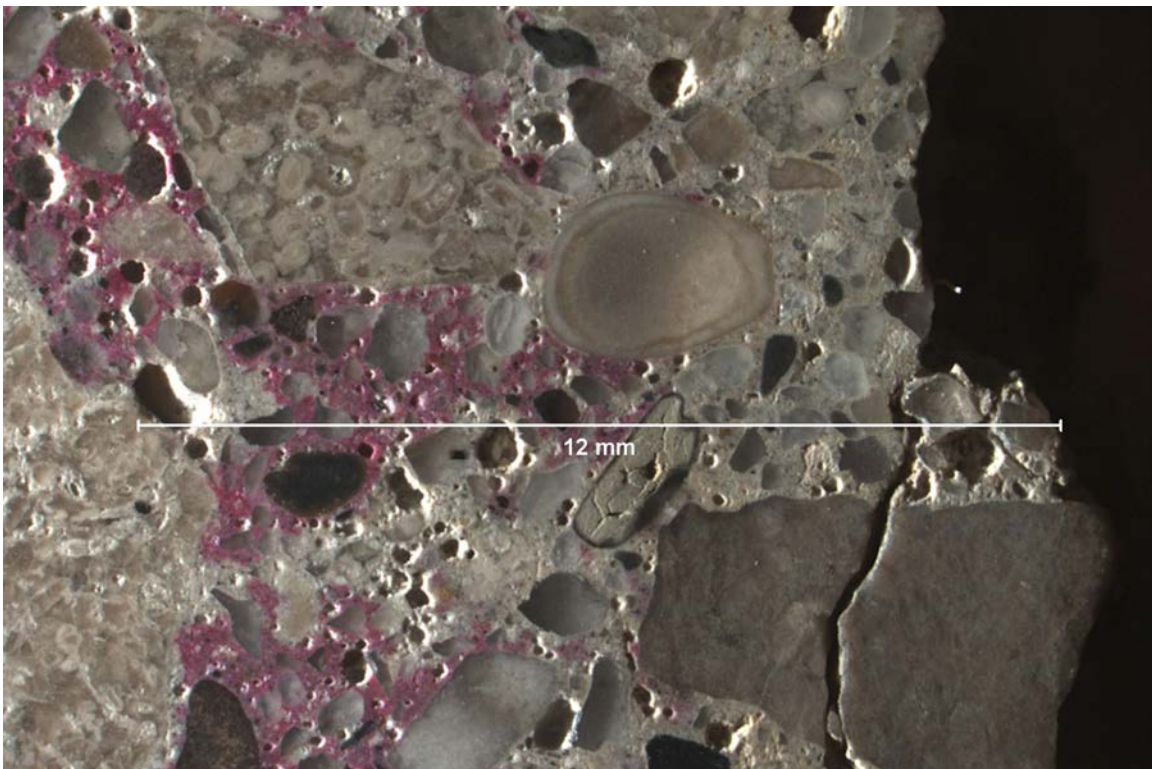
PHOTO: 14

SAMPLE ID: D **DESCRIPTION:** Apparent carbonation (unstained paste) proceeds up to 12mm depth from the distressed joint plane at approx. 75mm depth from the top surface.
